Goosnargh Mill Landslip

Project Description Sheet

Goosnargh, Lancashire

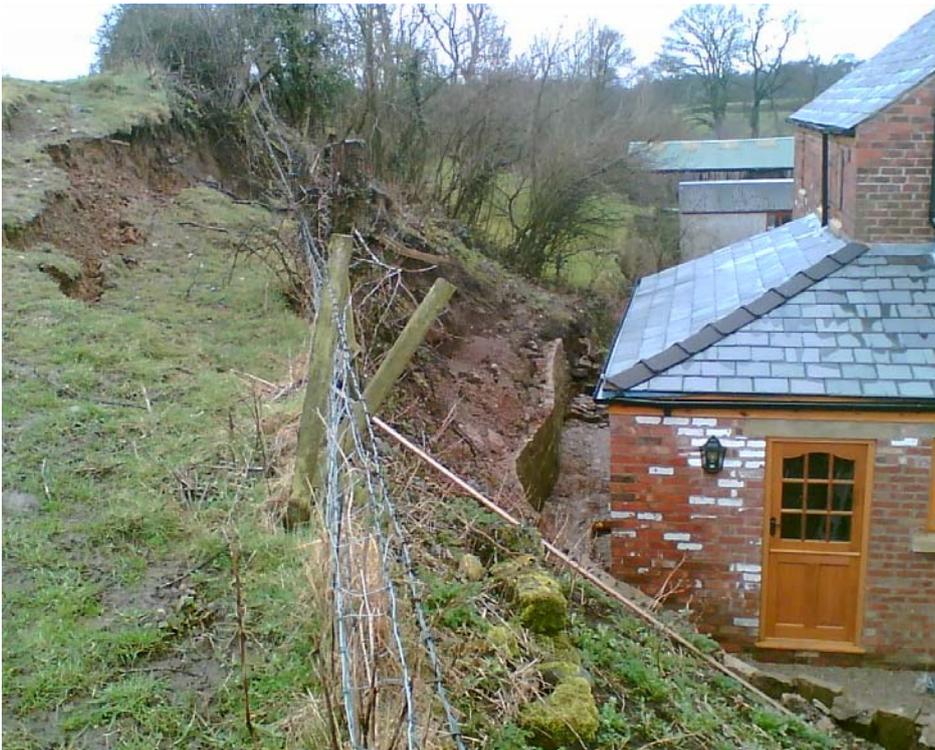
PSA Design were contacted to inspect a slope failure that had resulted in a slope adjacent to a property becoming unstable and slipping onto the home owner's land.

The likely cause of failure was a sequence of events that contributed to a sequential reduction in the stability of a slope that was already close to limit equilibrium. These events were; the removal of a tree and a period of heavy prolonged rainfall that increased pore water pressures in the slope.

Following assessment of the slope an options study was carried out to find the most cost effective remedial design. Recommendations were provided to revise the local drainage and provide a suitable re-grading profile for the slope.
